TURBO DIESEL Buyer's Guide

This Buyer's Guide was last updated 2/2015

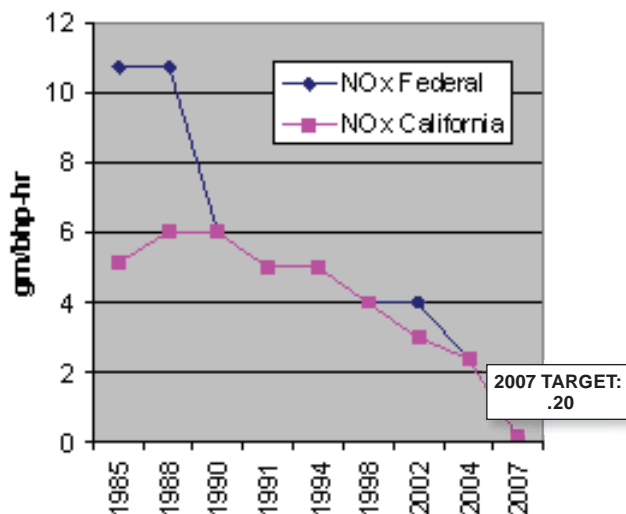
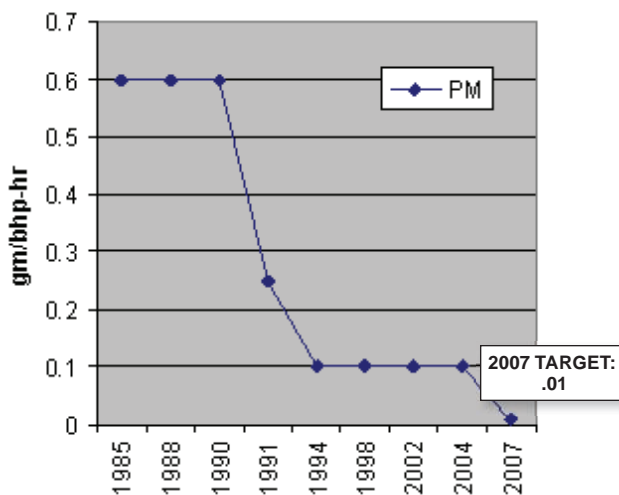
To oversimplify, think back to last winter and the many fireside evenings you enjoyed. As you built the fire, there was inefficient combustion, characterized by black smoke and not much heat generation. Thirty minutes into the exercise you were sitting back in the easy chair, with a raging fire, no more black smoke, a beautiful yellow and blue flame, and lots of heat.

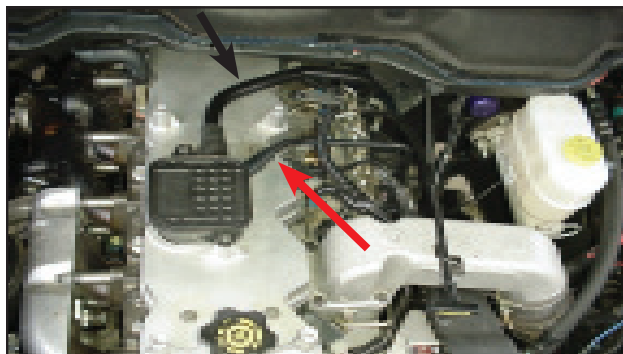
The 2003 crankcase vent system. The white arrow shows the inlet from the crankcase to the filter assembly. The red arrow points to the outlet hose that vents to atmosphere.

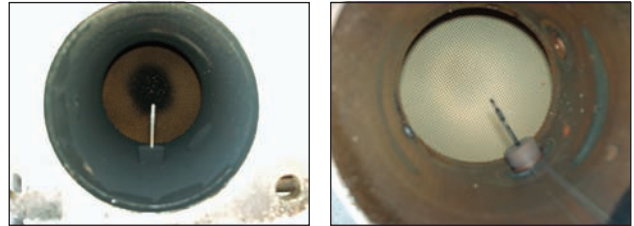
The "in" and "out" sides of the DPF.

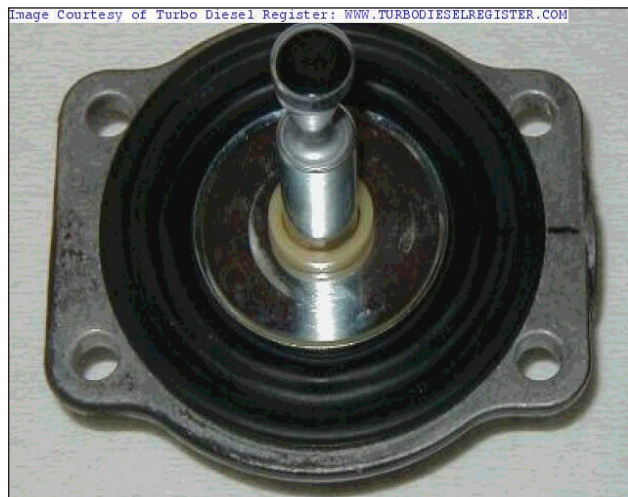
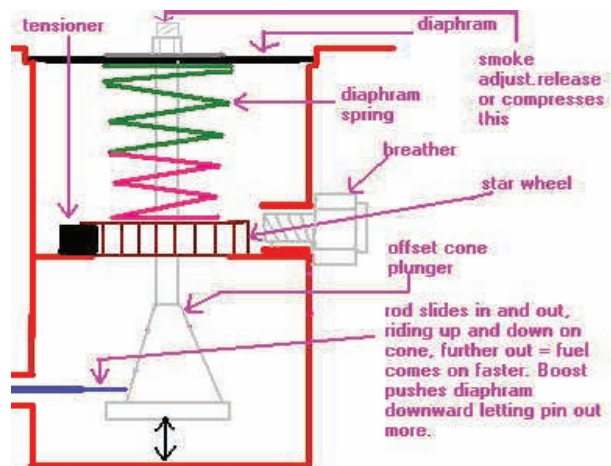
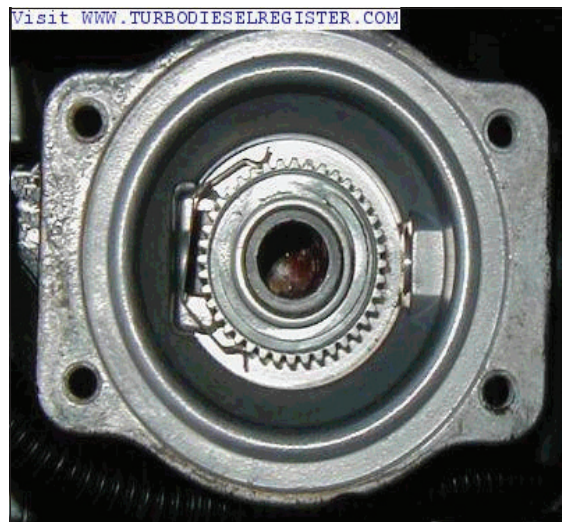
The starwheel. When you removed the diaphragm from the pump, you will have exposed the AFC spring. It is often a dual colored spring (it makes no difference which way is up). The spring sits on the *starwheel*. Rotating the starwheel up or down will place more or less spring load on the diaphragm. Turning this up (clockwise) will result in more boost being needed to start the deflection, and counter-clockwise reduces the amount of boost needed to perform the same deflection. Adjustment will also impact your overall smoke levels and mileage.

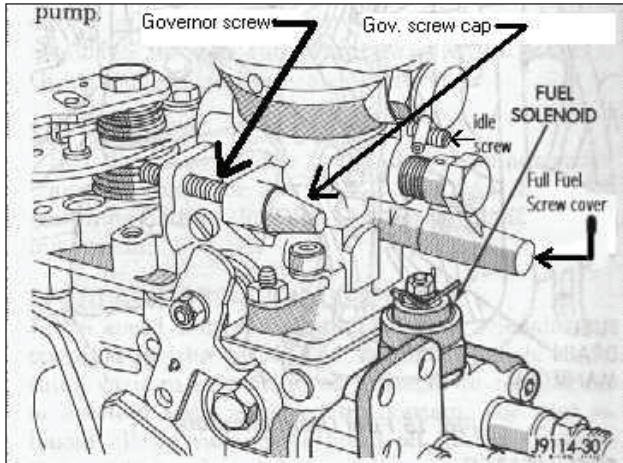
As you make adjustments to this screw, it fools your internal pump governor and results in an idle increase. Here is where the tachometer comes in handy! Why? Once you've had a pump go into *runaway* you'll understand. If that happens you'll need a board, some fast feet, or a friend standing by to help. A runaway engine/injection pump takes on a will of its own. In some cases turning the key OFF will have no effect. The volume of fuel being drawn overpowers the pump's ability to electrically shut off the flow. In this case, you'll need a friend with a piece of wood or other sturdy material, to place in front of the turbo inlet. This will starve the engine of air thus stopping the runaway. This may be obvious, but DO NOT use your hand . . . unless you are willing to be nicknamed “three finger Fred.”

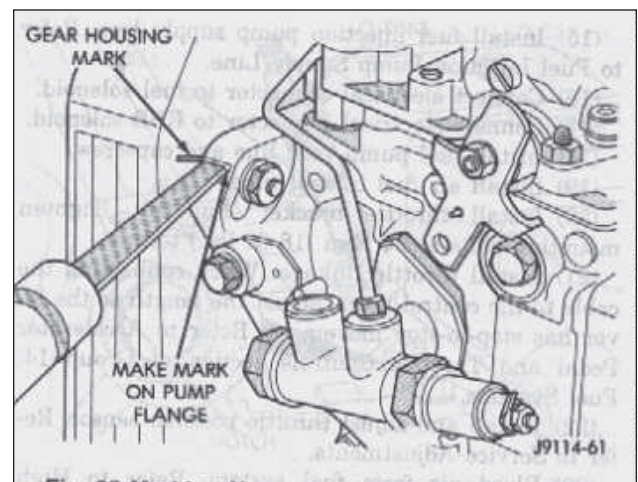
As a rule the pump timing can be increased to 15-17° advance or between 1.40mm to 1.50mm spill port lift, depending on the method used by the shop/mechanic. While it is occasionally difficult to increase a First Gen pump much beyond 17° advance, it is recommended that this is roughly the limit in order to maintain head gasket integrity, since advanced pump timing generates higher cylinder pressures.

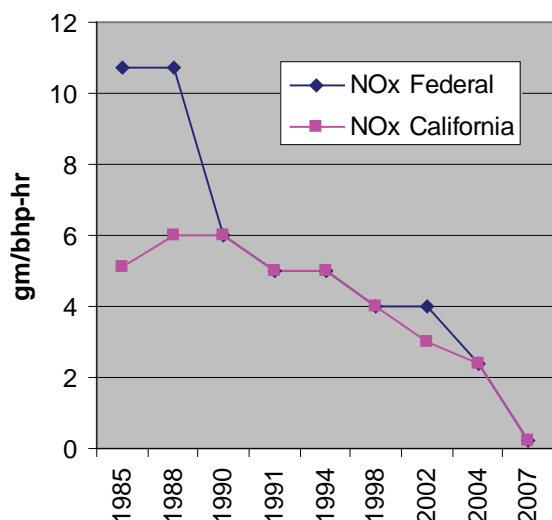
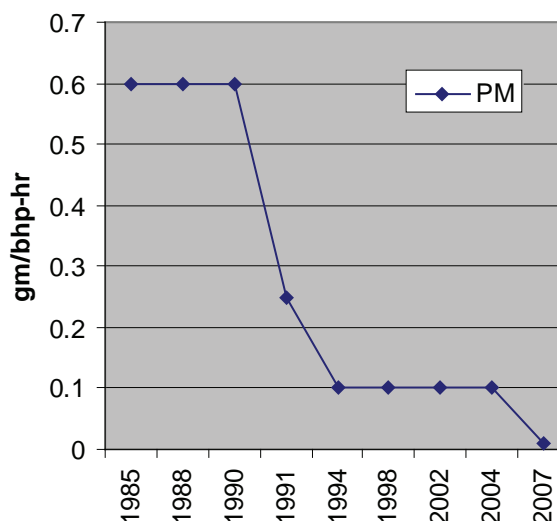
Particulate Matter (PM)

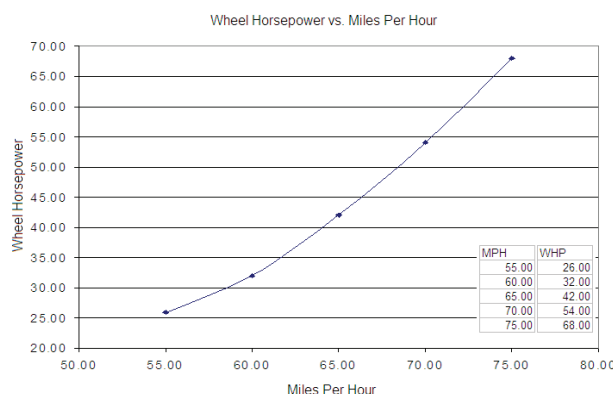
Next, we needed a way to accurately measure the fuel used during our testing. While we considered trying to carefully refill the stock Dodge fuel tank after each run, we quickly discarded that idea because it was impossible to fill that tank to the same level each time. We also considered placing a small tank in the bed of the truck that would be easier to refill to the same level each time, but that still

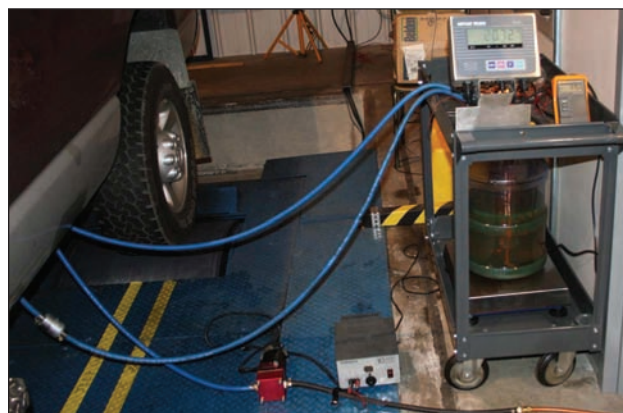
Ready to start testing? We thought so. We brought the truck up to 55mph on the dyno and set the truck cruise control to hold the speed. That part worked great. Next we started increasing the load on the dyno until we could repeat the horsepower number we found from the earlier Interstate highway testing. That part worked great too. Then we drove the truck for five minutes at these conditions taking the fuel weight before and after the test. That part worked great too. Well, almost. One of our technicians accidentally touched the five-gallon jug and realized it had become very hot from the engine's returned fuel.

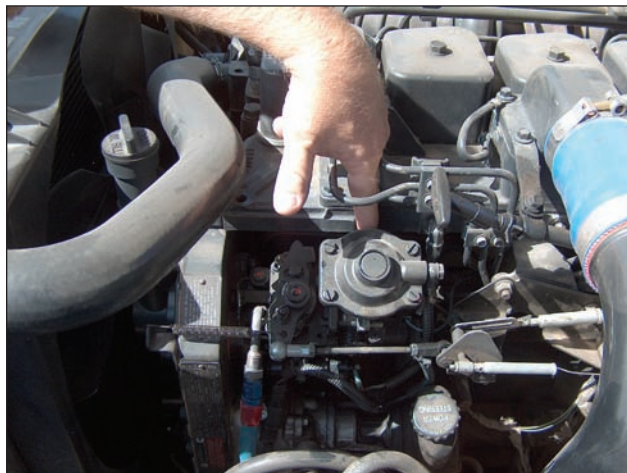
A Bosch VE pump on a Cummins B engine, with a finger showing the clearance between the AFC module and the cylinder head.

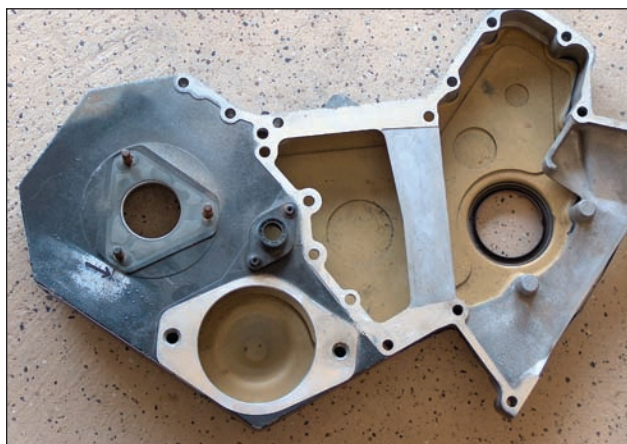
Engine side of a VE-pump style Cummins gear housing.

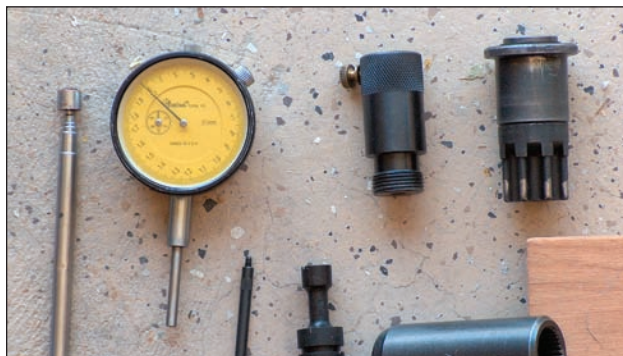
T5. Miller MLR-6860 P7100 pump timing tool kit. At the left is a magnet on a telescoping “stick.” To its right is the dial indicator with the stem extension below and to its right. To the right of that is a timing pin with a steel tip epoxy glued onto it. The special splined socket is at bottom right, with the splined end resting on a block of wood. At top center is the adapter that holds the dial indicator and screws into the top of the pump barrel. At top right is an engine barring tool that plugs into the aluminum block adapter plate and meshes with the flywheel teeth.

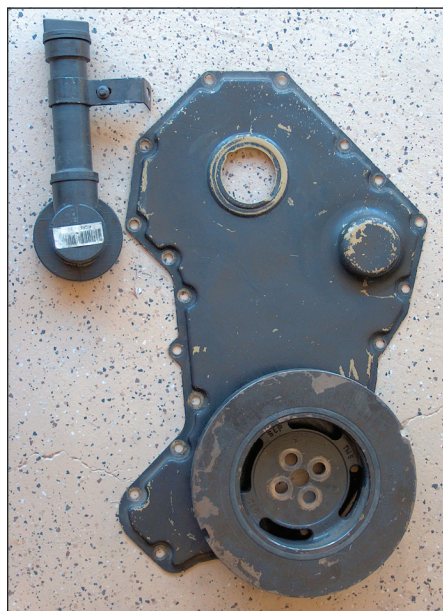
T10. A Cummins gear housing, front side, with the oil filler tube at yop left.

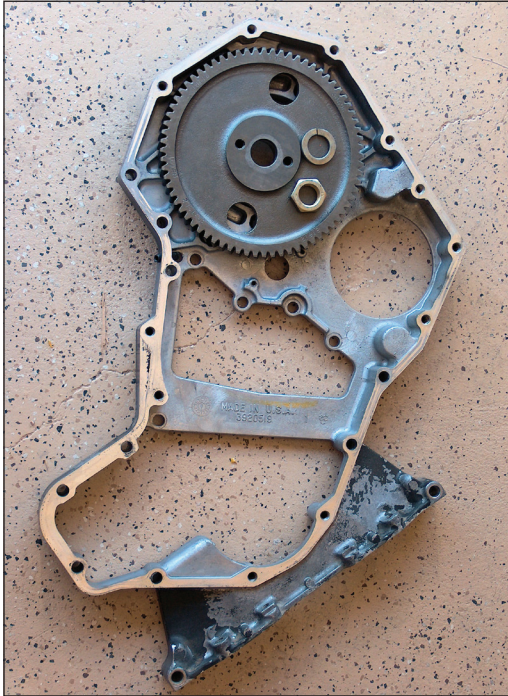
T11. A Cummins B gear housing with a P-pump drive gear, washer, and nut.

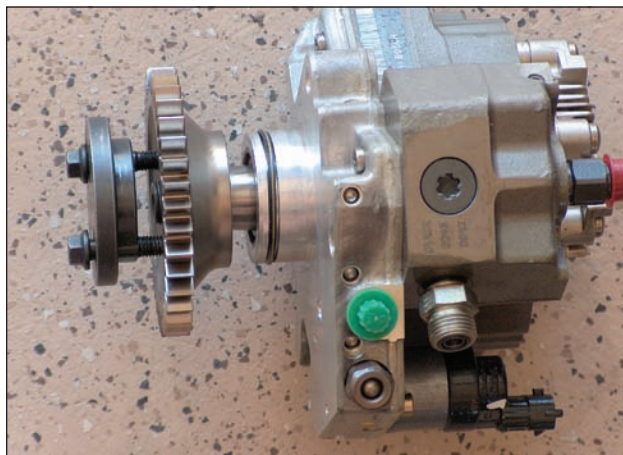
T12. Use of the SP504 gear puller is illustrated here with a Bosch CP3 pump.

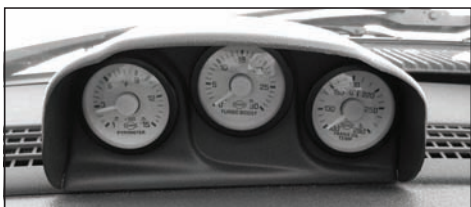
As mentioned, with a gauge installed you can use the boost readings as a diagnostic check of the engine's performance. The engine will need to see a full throttle, loaded condition in order to make its maximum boost number. The easiest way to do this is to drive the truck up a hill. No hills in Kansas? Apply the brakes to load the engine.

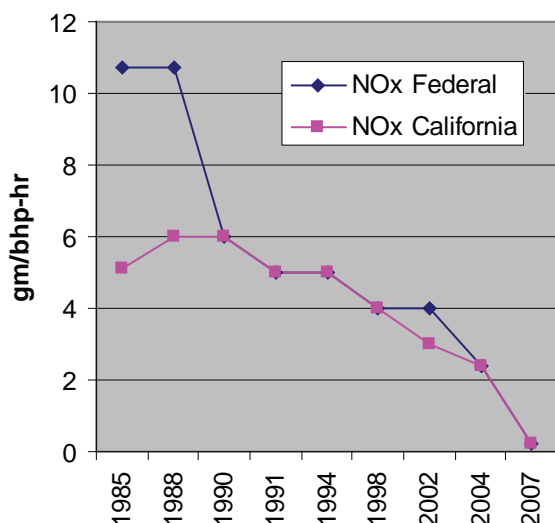
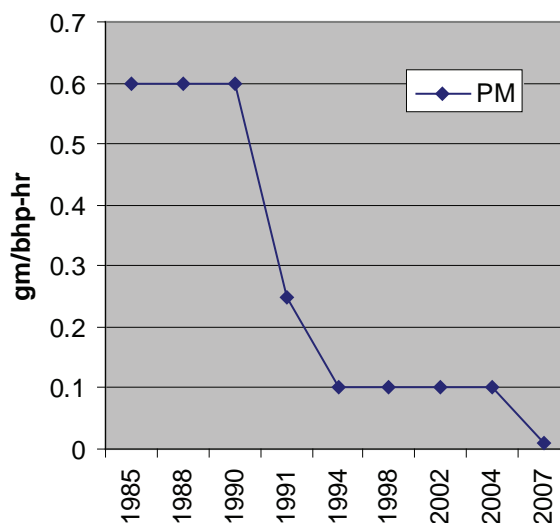
Particulate Matter (PM)

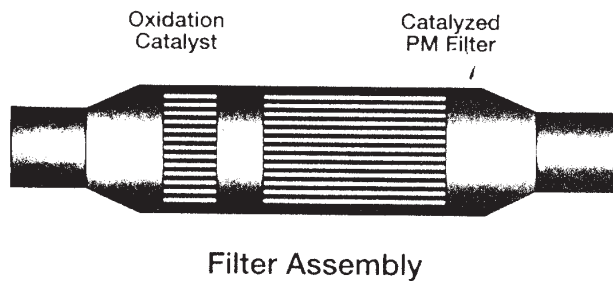
As oil is consumed and particulate matter is burned off through regeneration they become ash and collect in the filter. The ash must be cleaned from the filter or plugging will occur. Maintenance may be required on diesel particulate filters.

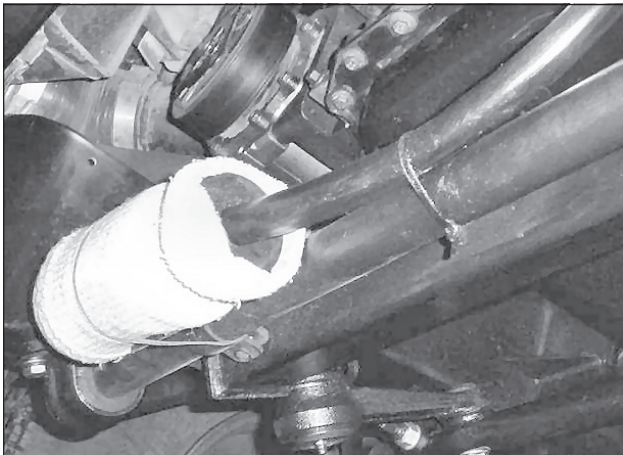
The old cotton sock idea is an easy fix with no drips or oily film on anything but the outer sock. I replace the sock while I am under the truck changing oil. I extended the tube and drip catch bottle down to the anti-sway bar and secured it with a couple of wire ties.
Gary-K7GLD, Canyon City, OR

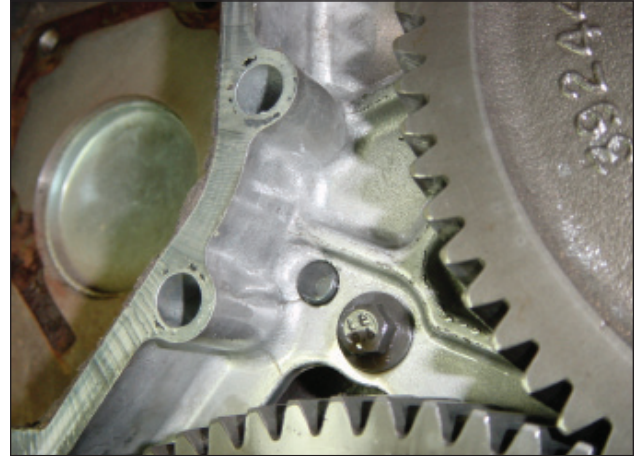
A close-up picture of the dowel pin.

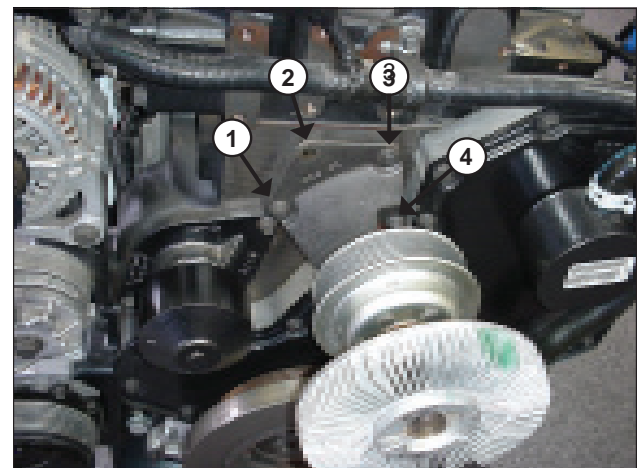
- 7) CAREFULLY work the fan and the fan shroud out together. This takes time, so go slow. Working with a friend helps. Make sure not to DAMAGE the radiator cooling fins or any hoses that may be in the way.

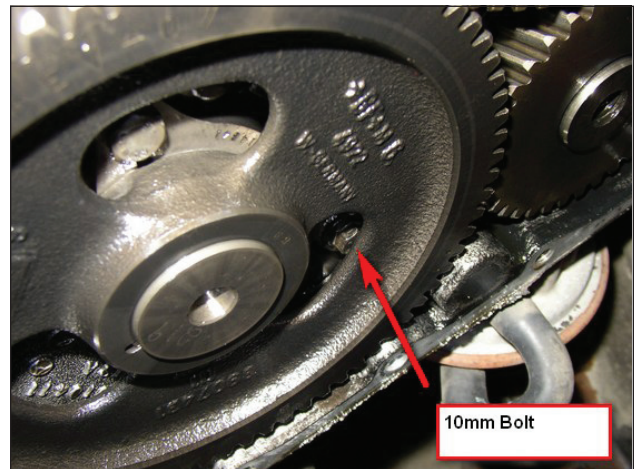
RedRamAndy, Wentzville, MO

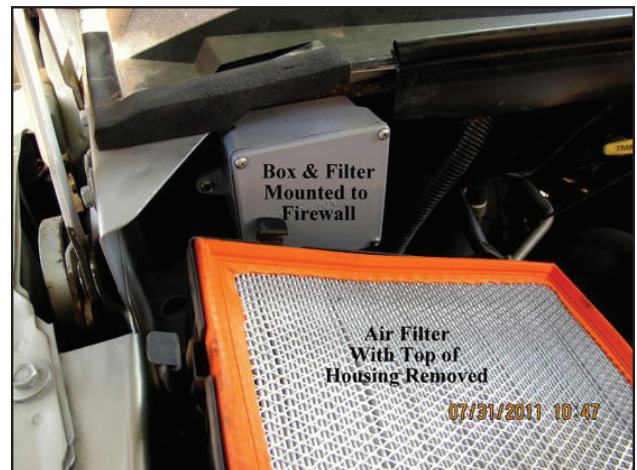
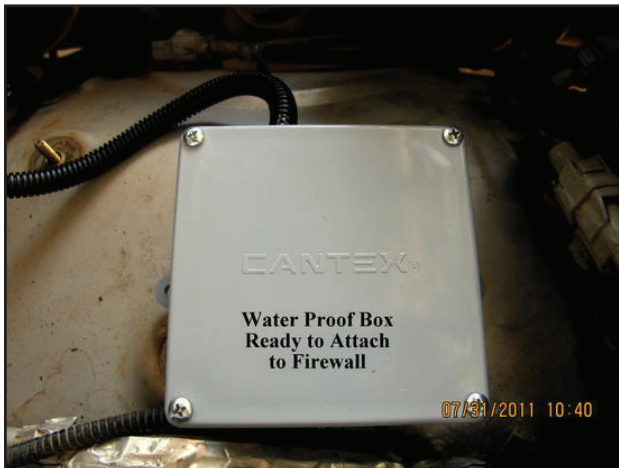
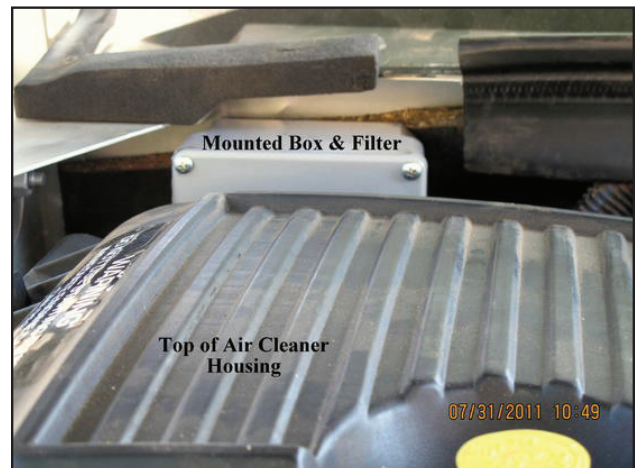
Silver Ratler, Lubbock, TX

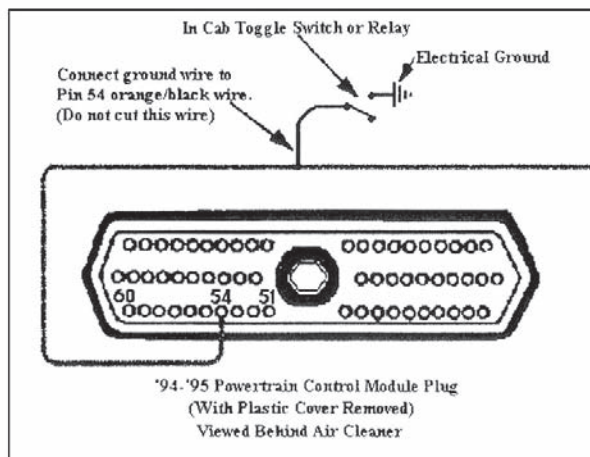
Block 53 and Class Action Settlement

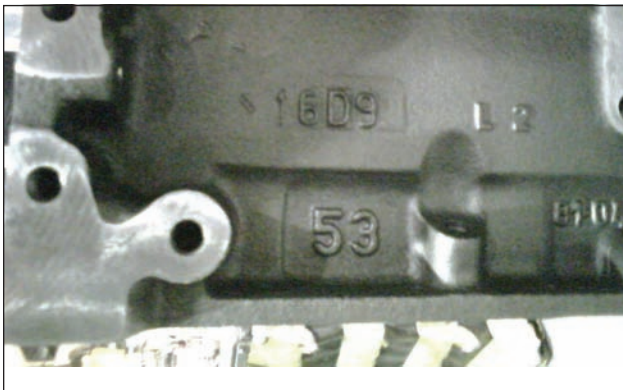
You can't miss it, "block 53," on the driver's side of the engine, toward the front gear case, behind the vacuum pump.

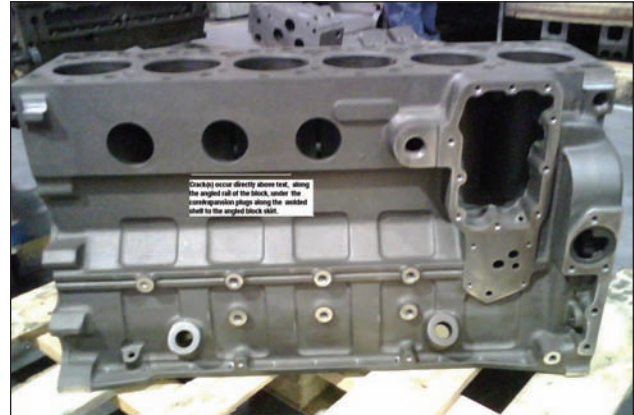
Crack(s) occur directly above text, along the angled rail of the block, under the core/expansion plugs along the molded shelf to the angled block skirt.

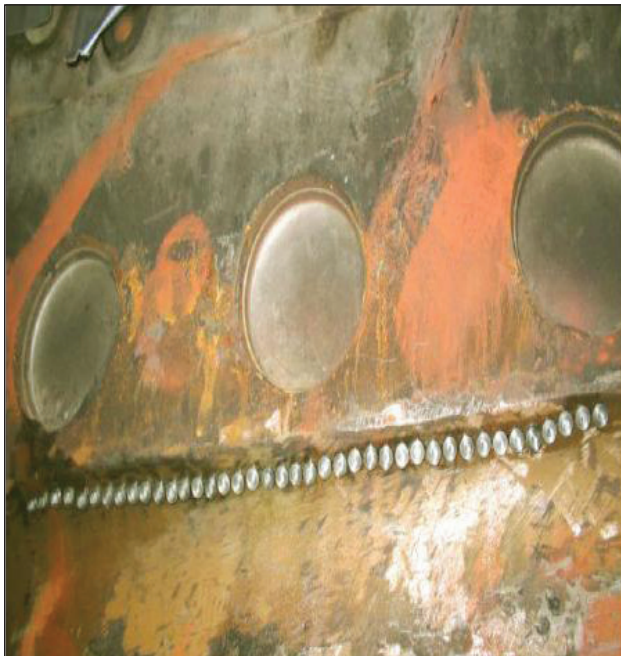
Before you call this a complete repair, take some time to prevent future cracking. Lock-N-Stitch sells a support bracket (\$375 each) that adds strength to the block in this weak area. It is recommended that one support bracket be used for cracks that are up to 3", two brackets for cracks that are 3" to 6", and three brackets for cracks that are 6" to 12".

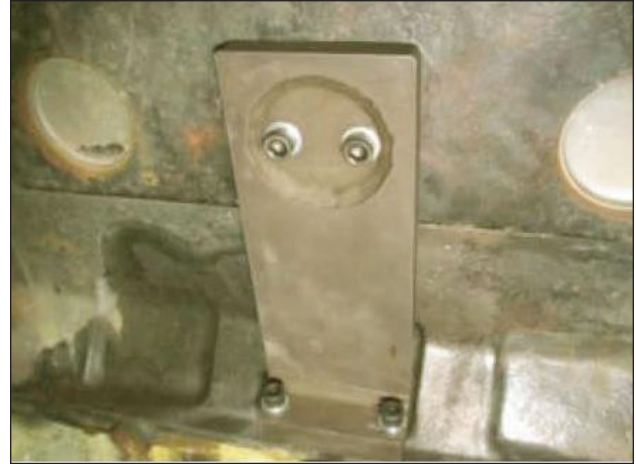
Reinforcement Bracket

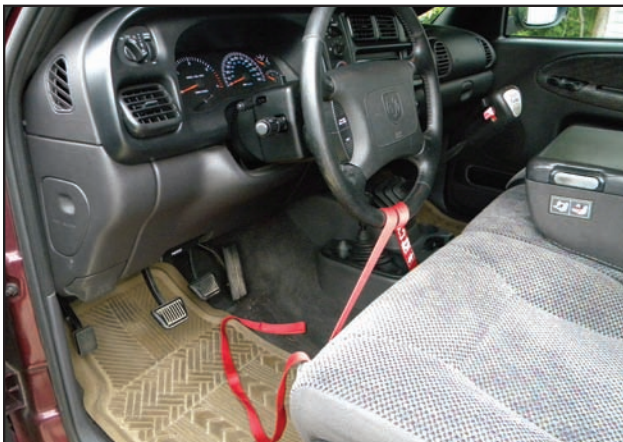
This technique makes the steering stay put while you work which avoids clock spring damage.

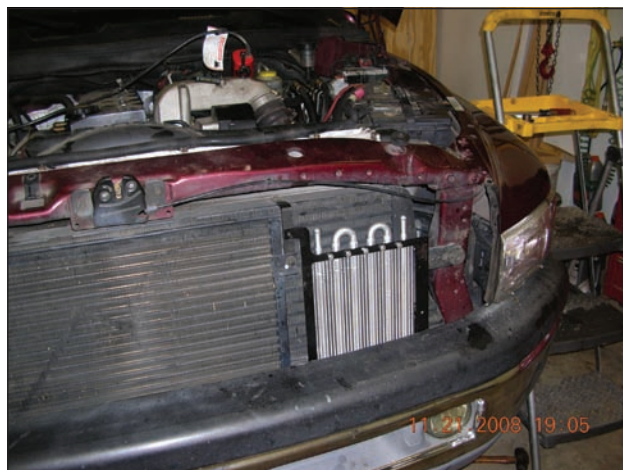
An automatic transmission fluid cooler in its new job as a power steering fluid cooler.

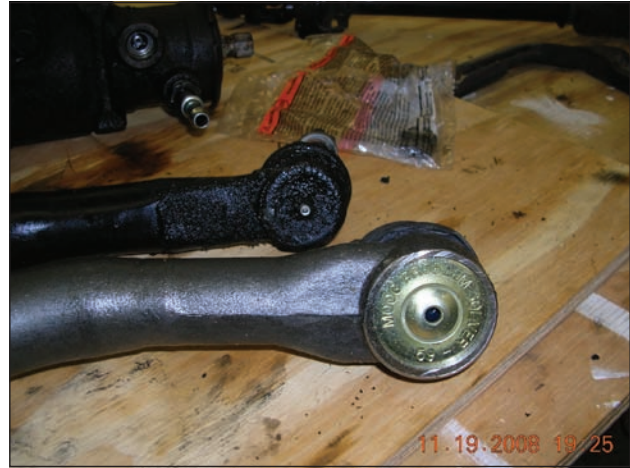
This track bar replacement settled the truck down quite a bit and gave it some fairly decent road manners. I drove the truck for several months with it at this stage and decided that while it was tolerable, it still lacked the control and stability it had when new.

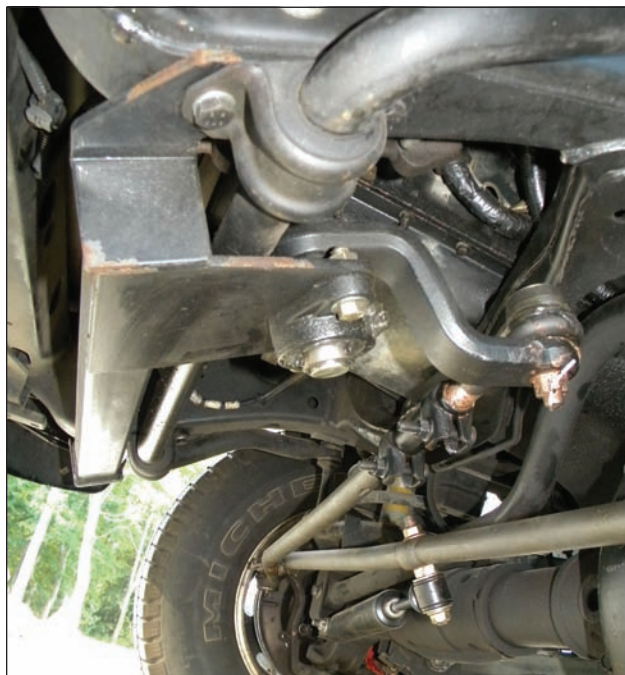
The BD steering box stabilizer enhances the truck's steering system by giving the steering shaft support out past the point of load application which reduces stress on the steering box's output shaft bearings. It also stiffens the frame rail near the steering box mounting location, reducing side-to-side flexation.

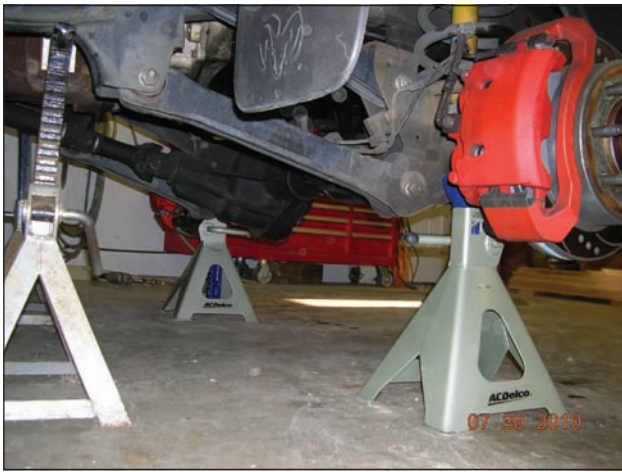
Once the truck is safely up on the jack stands and you are confident it is there to stay, remove both front wheels. The next step is removing the brake calipers. Plan to hang them from the control arm using a wire, a Ty-wrap, or a hook so that the brake hose is not stressed. Never drop the caliper or allow the hose to hold the weight of the caliper. The brake rotor should now slide off to reveal the bearing hub. (Unless you have a '94-'99, which is a different design.)

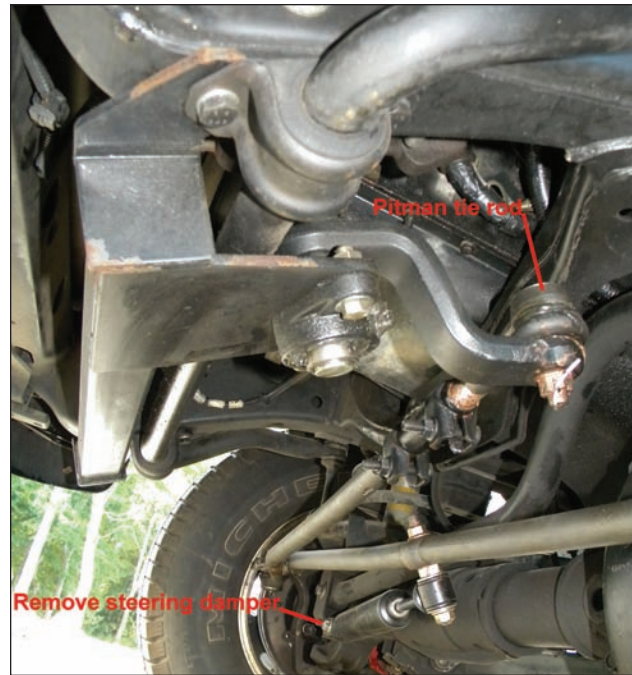
Remove steering damper.

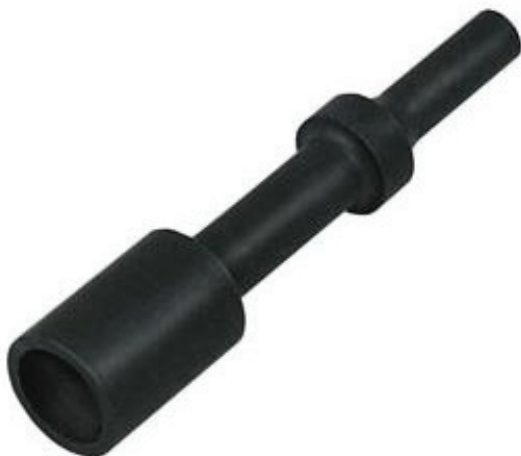
Andy Redmond adds to Brent's story: I've used all the methods for stuck hub bearings and by far both the easiest and best method is the deep socket extension trick or Snap-On Tool DHP1. Use of the Snap-On tool wedged against a loosened bolt and against the axle tube while an assistant turns the steering wheel will pop them loose every time. Alternate the tool between the bolts to walk it off little bits at the time. In fact, I can even do it by myself, although it's a lot of running back and forth. Most DIY's don't have an air chisel or compressor with adequate power for Brent's pneumatic impact hammer task, plus you don't ruin what bit of hearing you have left, huh?

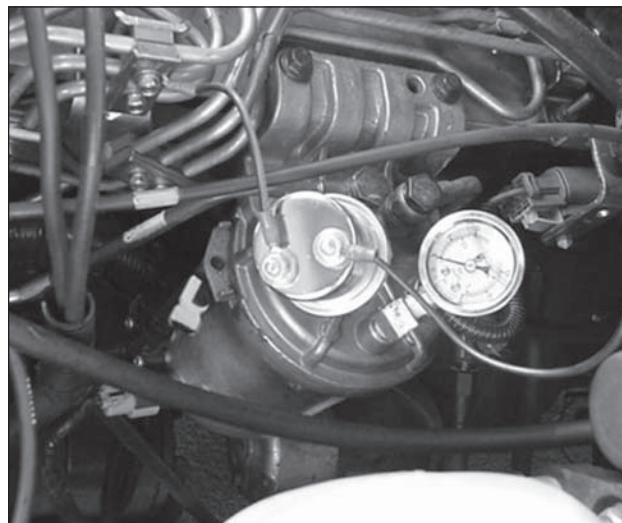
In the photo, note that the Editor's truck (a '99 model) is outfitted with two gauges—one is a mechanical, liquid-filled gauge and the other is a Westach electrical gauge with a pressure sending-unit mounted to the filter head assembly.

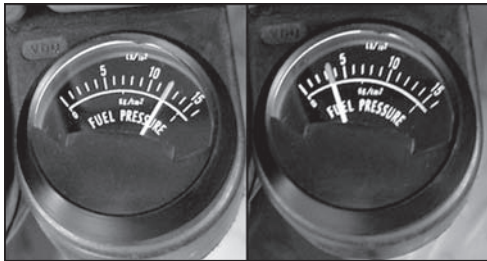
FROM ISSUE 40: '94 TO '98 12-VALVE FUEL TRANSFER PUMP REPLACEMENT

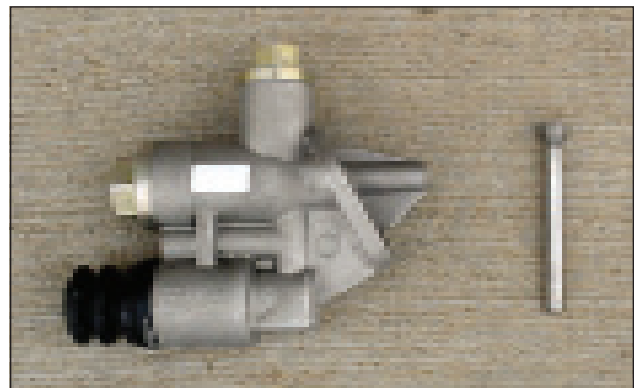
Carter lift pump with plunger removed.

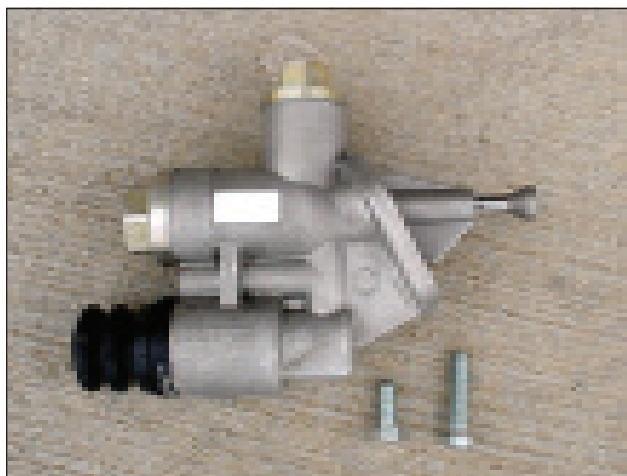
Carter lift pump with regular mounting bolt and longer temporary bolt.

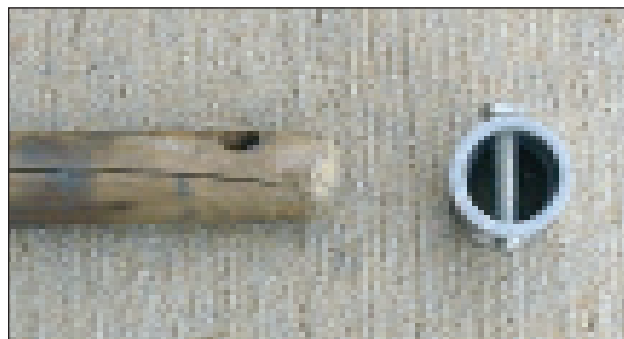
Broom handle, $\frac{3}{4}$ " coupling with hole drilled and bolt.

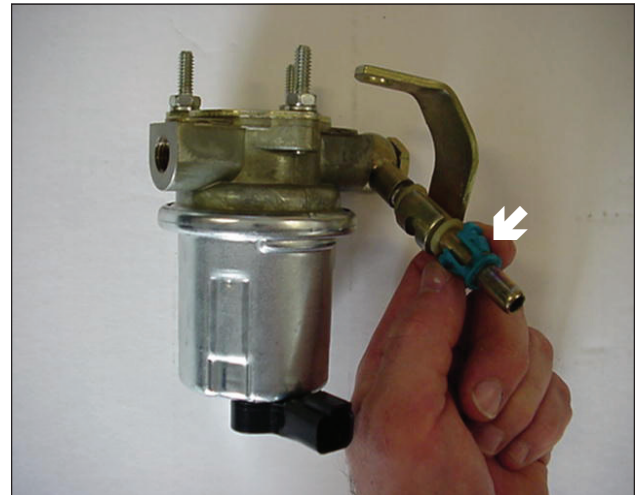
Pinch the blue disconnect and the fuel line will come loose.

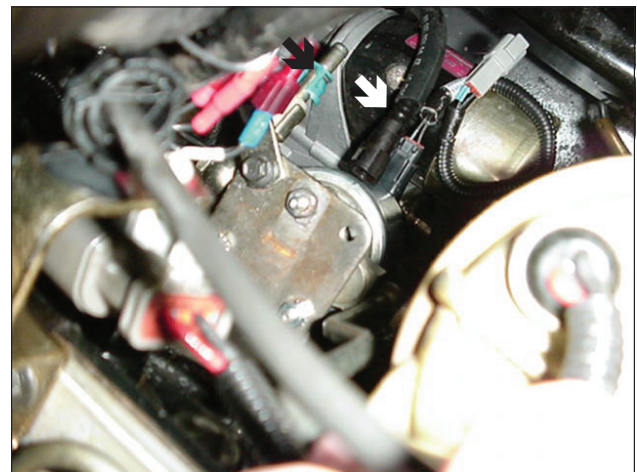
The fuel line to the transfer pump and the fuel line that goes to the fuel tank are pictured here.

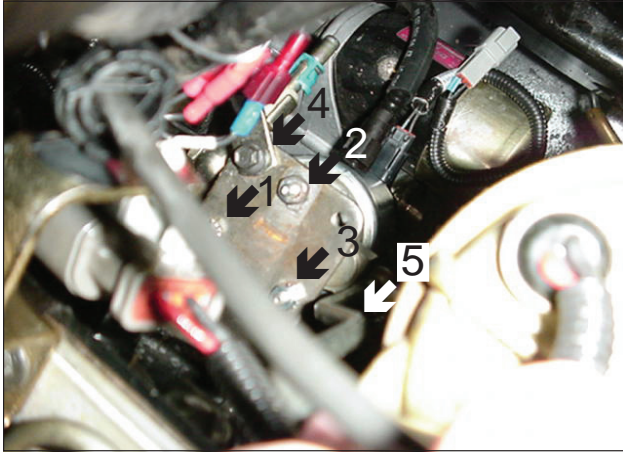
The three 15mm nuts that hold the fuel transfer pump in place (1-3) and 10 mm bolt holding the fuel line (4). Arrow 5 points to a fuel line that you have to remove with a 17 mm stubby wrench.

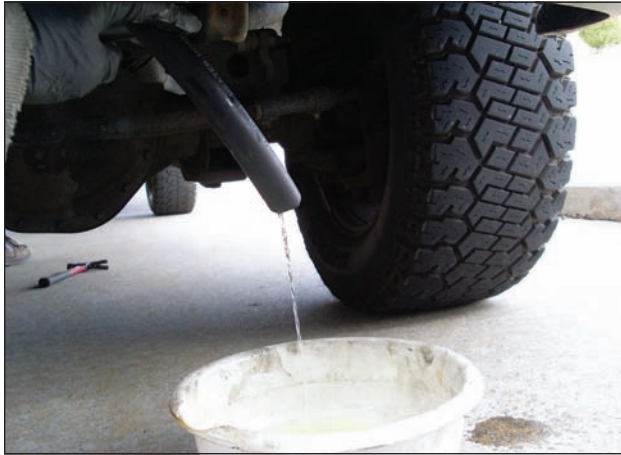
Extend the fuel filter drain hose to save the aggravation of having the fuel drain onto the frame which is caused by the existing short drain hose.

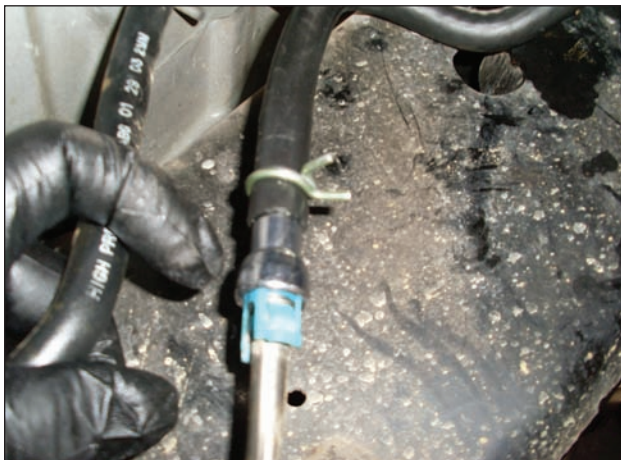
Pinch the outer tangs of the fuel line quick-fitting to separate the rubber hose from the hard fuel line.

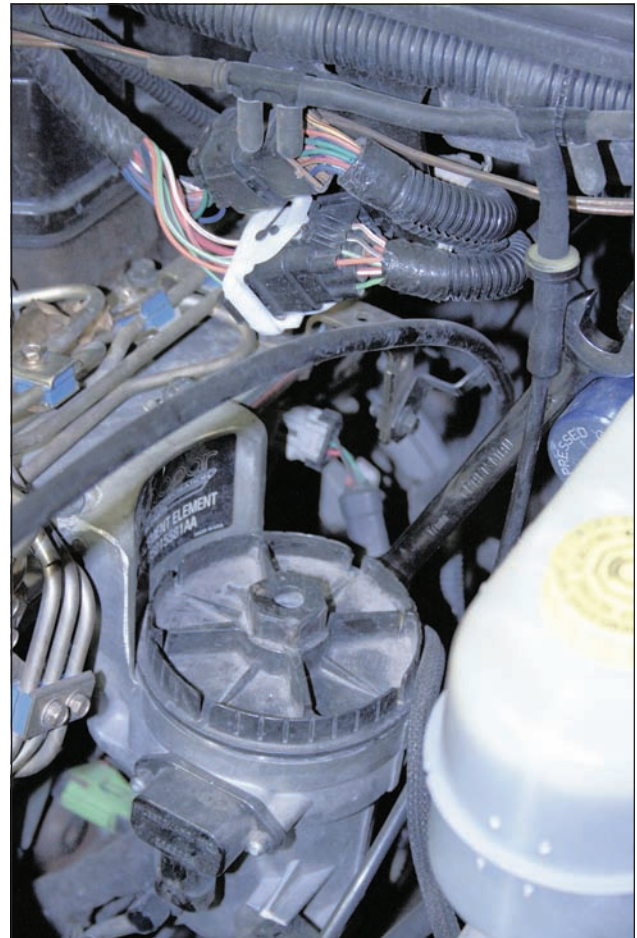
The following is a pictorial installation of the DDRP on a '00-'02 model year truck. The lift pumps are the same for the '98.5-'99 model trucks, but there is a slightly different fuel transfer pump outlet, fuel line plumbing and fuel filter assembly.

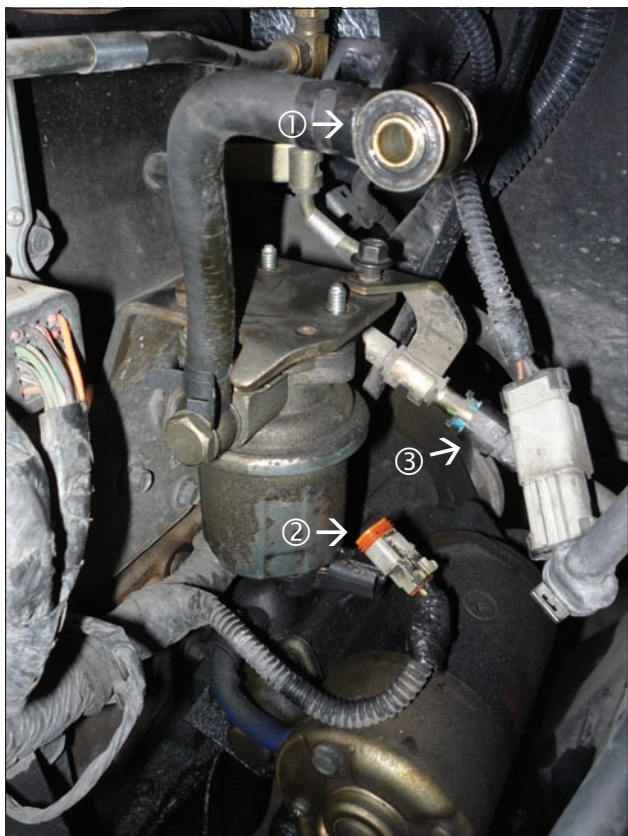
It is not necessary to remove the fuel filter housing to replace the lift pump. The arrow points to a 17mm wrench that is used to remove a banjo bolt that holds a fuel line from the fuel transfer pump to the fuel filter canister.

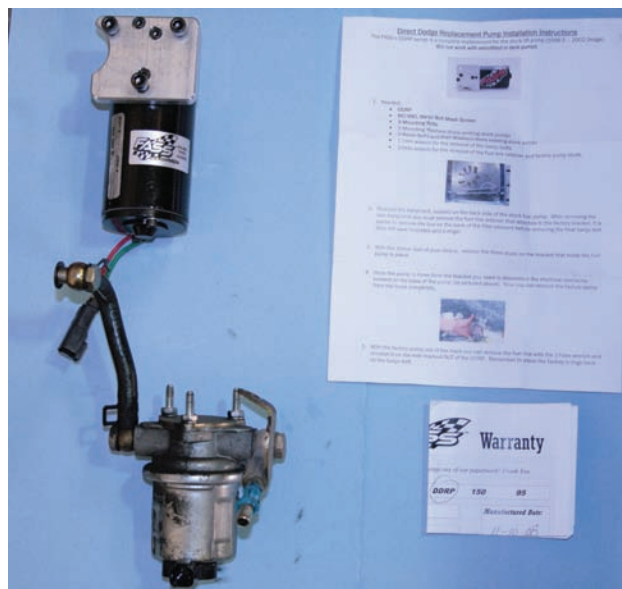
①the pump outlet pipe; ②the Deutsch electrical connector disconnected; ③the fuel transfer pump inlet piping, with blue quick-disconnect fitting. The fuel transfer pump is attached to the support bracket with three nuts (13mm) and one inlet pipe bracket support fastener (10 mm head). Those that have changed a few of these fuel transfer pumps know how frustrating it is for the 13mm nuts to loosen the studs. If the stud spins with the 13mm nut you have to go underneath the support bracket with a thin 7/16 open wrench to hold the stud to keep it from rotating. Look at photo C, item ① and you'll see what I mean.

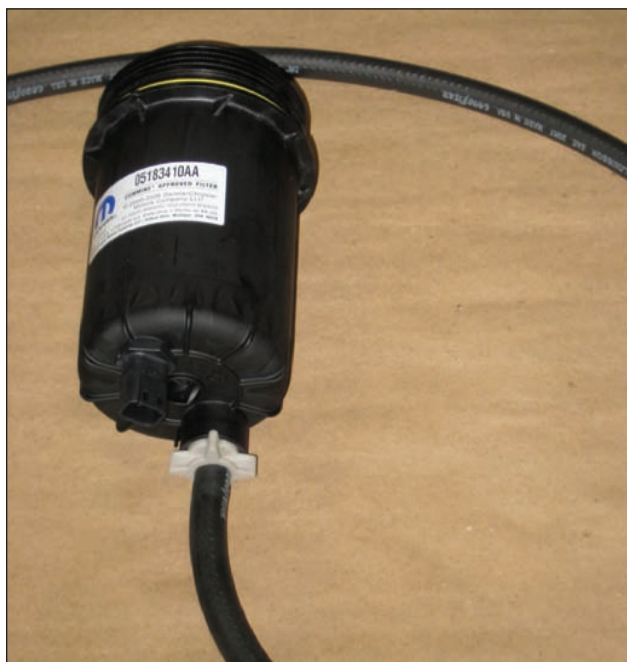
Let's Begin the Fuel Filter Change

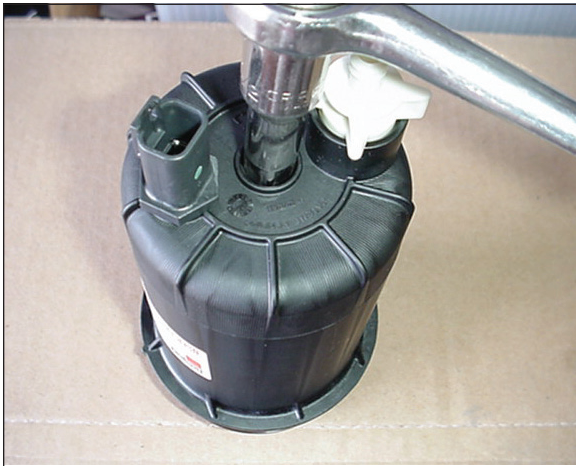
I'll bet you didn't know that there was a 1/2" drive indentation on the bottom of the filter canister.

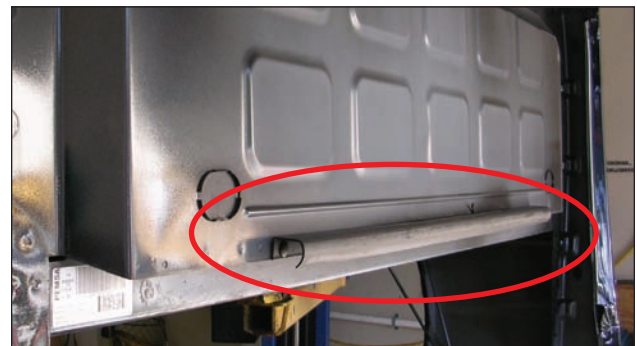
The plastic truck bed snubber.

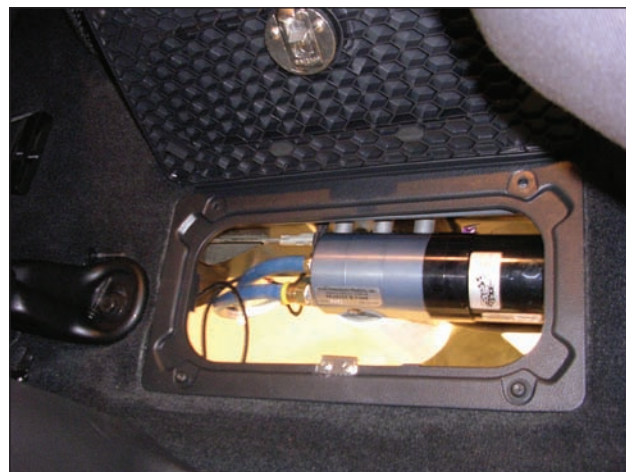
From above, a picture of the FASS unit that I installed on the outside of the driver’s side frame rail.

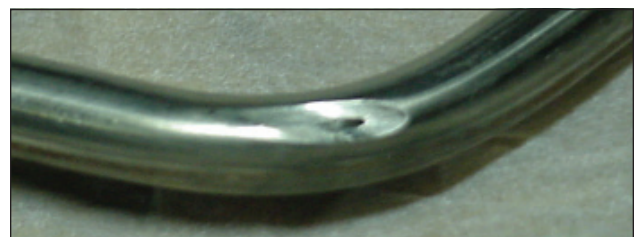
The module has metal pipes exiting the top of the module (supply and return) and has hard plastic tubing coils that extend to the bottom of the module where a removable screen covers the pickup and return. Most of them that I've dissected have a one-way check valve in the fuel pickup to assist in holding fuel prime. Many members have noted that these lines sometimes chafe and develop a pinhole, which allows for fuel aeration, not a good thing! The perforated tubing seems to have rubbed on a sharp edge, or on the mounting hardware for the lower float we previously discussed. The return also returns fuel to the bottom of the module (above tank bottom about 1/4"). This is preferable, as it allows returned fuel to be released into the remaining fuel rather than spraying on the tank's upper surface introducing foam and air.

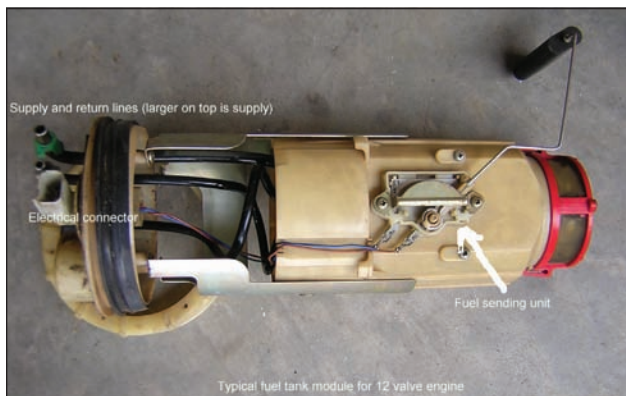
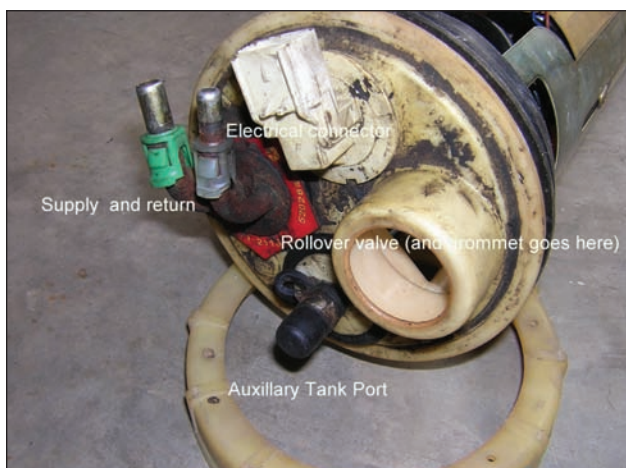
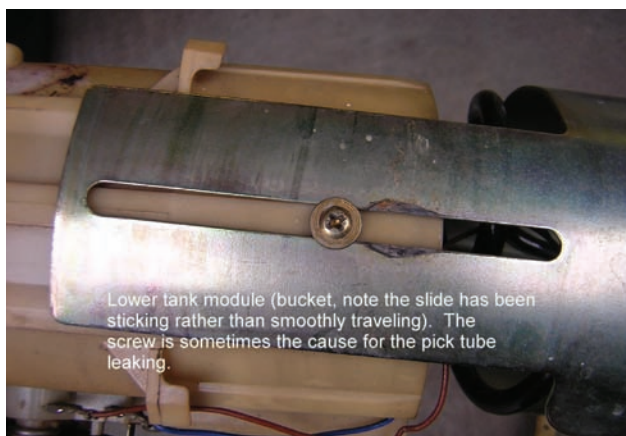
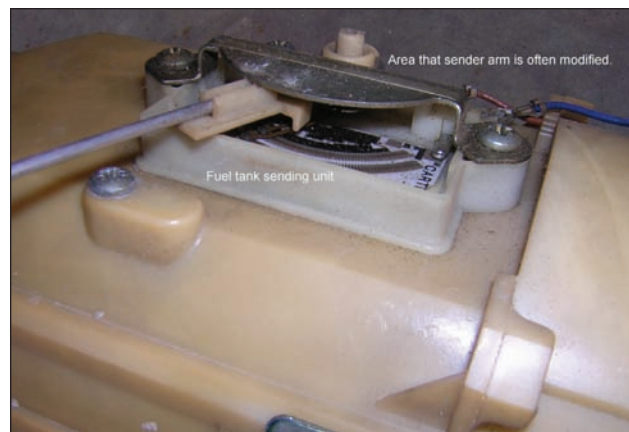
Permit me to further digress: I recently made a road call to visit a sick '95 model truck. The owner complained of a tapping noise and suspected connecting rod since the truck showed about 250,000 on the odometer. Over the phone when he held it near the source of the noise it sounded to me like a worn out lift pump tapping away on the cam lobe. The problem was missing fuel line routing brackets, which mount to the bell housing. It seems that the clutch had been recently changed and I assume the technician was speeding along attempting to "beat the book" (flat rate) and didn't see the need to attach the awkward brackets. The supply and return were chattering away on the bell housing which was driving its owner to near insanity. Some zip ties and split pieces of fuel line temporarily solved the problem while the replacement brackets were ordered.

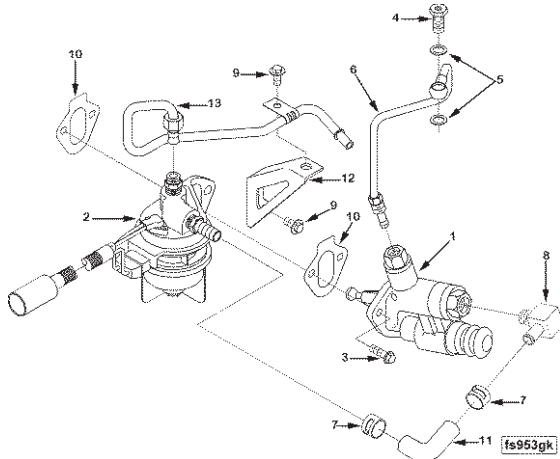
1998 12-valve illustration, part number 13 differs on 1994-1997 designs.

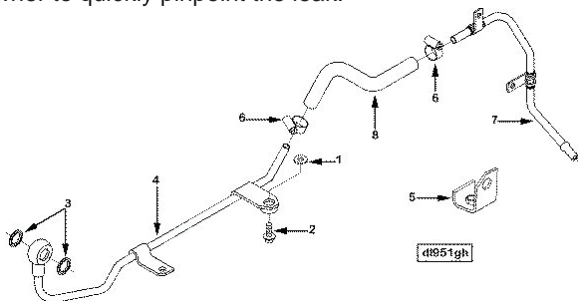
Notice the return line parts diagram: (illustration for 1998 12-valve). Part number 8, rubber fuel return line, is about three times as long on the earlier 12 valve applications. Also, part no. 7 is different as well.

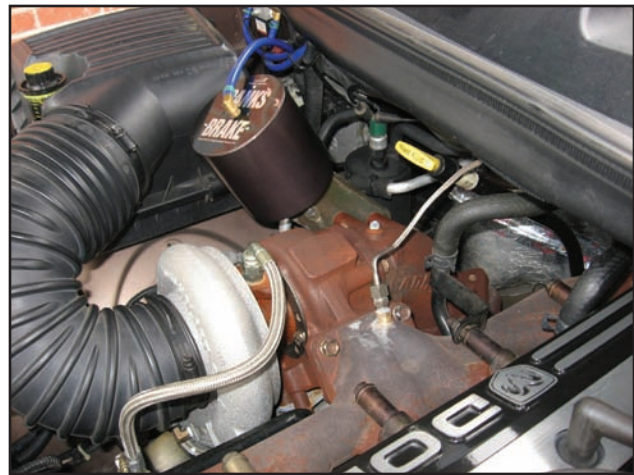
The Banks Brake on my truck is typical of turbo-mount brakes, replacing the stock transition elbow that connects the turbocharger to the downpipe. Being under the hood makes them less exposed to the elements than the inline models and also makes installation a simpler, bolt-on procedure. Mounting close to the engine also keeps the run of hoses to a minimum with less chance of damage. If you have twins or a non-stock single turbo though, this type is not an option.
