TURBO DIESEL Buyer's Guide

This Buyer's Guide was last updated 2/2015

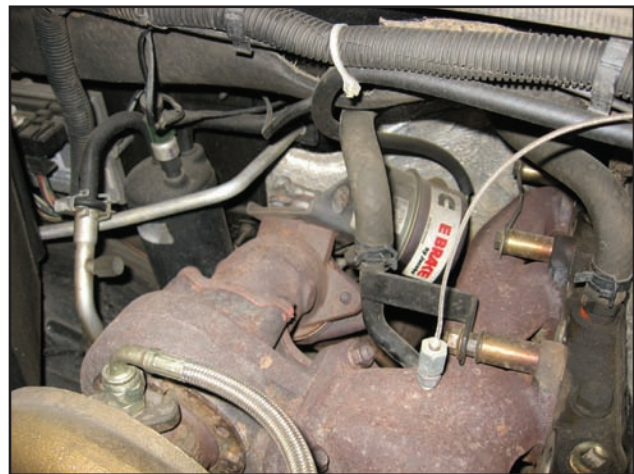
This picture is of the Cummins/Jacobs version of a turbo-mount brake installed on a 2002 truck. The vacuum cylinder is smaller and is positioned down lower next to the firewall than the Banks version.

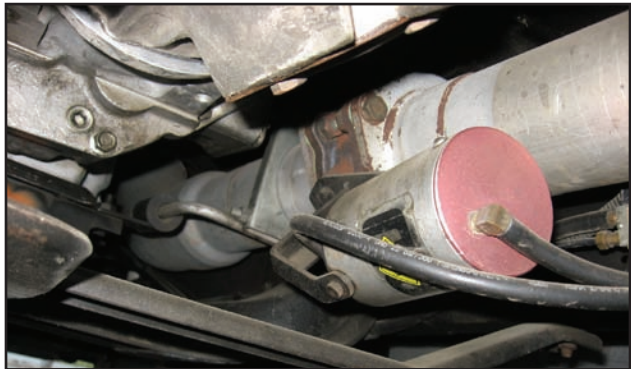
You can see that the inline, under-truck mounted exhaust brakes install in the exhaust pipe instead of directly on the turbo. They are a little more work to install because the existing exhaust pipe must be cut to allow the brake housing to be inserted. They are more exposed to the weather in this location. This one has the flanges nicely welded to the 4" pipe for a leak-free installation.

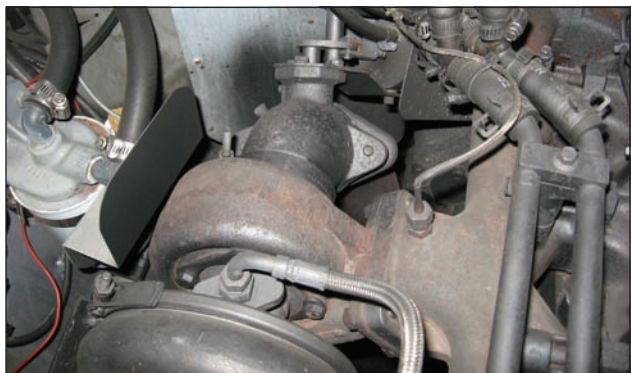
This picture shows a PacBrake installed on a First Generation, manual transmission equipped truck and is very similar to the Jacobs in the positioning of the air cylinder.

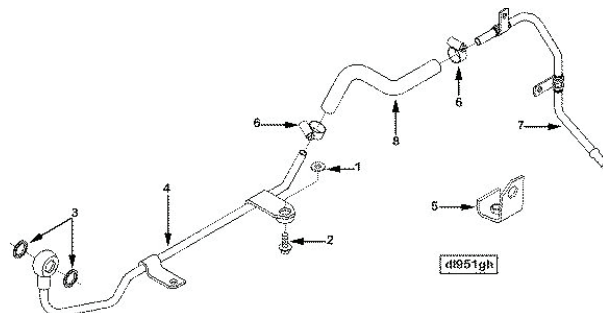
Look closely for the problematic fuel return line.
